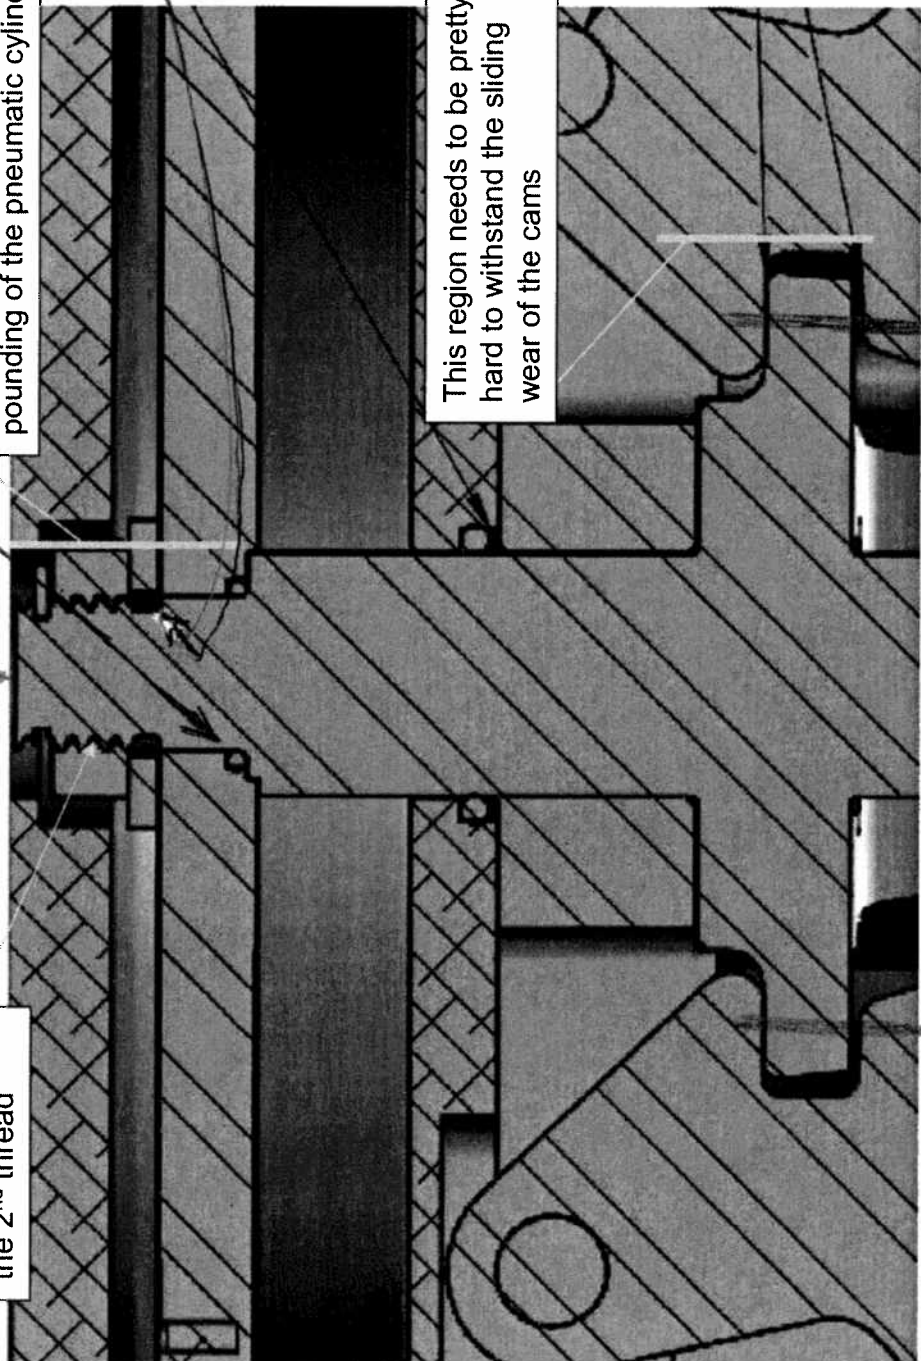
CAN THIS BE
BROUGHT STRAIGHT
DOWN? (REDUCES
SPRING CONSTANT
ENDS?)

Failure occurred
here, at the root of
the 2nd thread

This region needs to be pretty
tough to withstand the tensile
pounding of the pneumatic cylinder

This region needs to be pretty
hard to withstand the sliding
wear of the cams

← AIR
GAP?
IS THIS A
PRESSURIZED
AREA?

THIS CORNER MAY
CONTRIBUTE TO
STRESS CONCENTRATION
AT THREAD ROOT.

IS THIS
PLATE IN
BENDING?

✓ CAMS PRODUCE
AXIAL LOAD HERE?

YOU WANT
TO PREVENT
ROTATION
HERE. MAKE
PLATE DEEPER
AT SHAFT
