## McIntosh Power and Speaker Switch, ALPS 146-183, Repair

April 2022

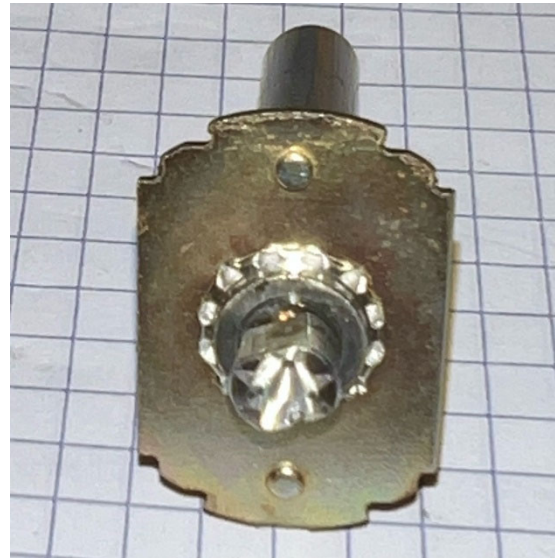
6) Remove and set aside the reddish phenolic part which separates the front plate from the switch housing. Now you should clearly see the flared shaft which held the original actuator as shown in this photo:

7) Now use smooth jaw pliers to squeeze the flared shaft back into a round shape. This is needed to allow the shaft to be pulled out of the bushing and to assure that the new actuator can be properly snug fitted on the shaft. Parallel jaw pliers are recommended to minimize shaft distortion. If necessary use small files to complete the shaft shape restoration. If the shaft cannot be pulled from the bushing do a bit more squeezing and filing.

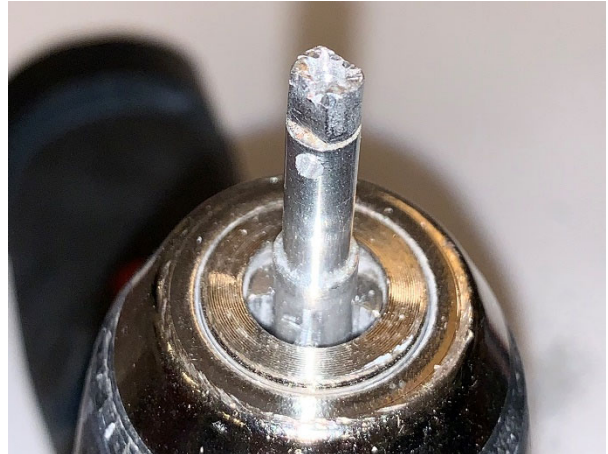
- 11) Use the same tap drill (#51 for #2-56 tap) to cross drill a hole through the round shaft near where the actuator is mounted; about 3/8 inch from the actuator end of the shaft. This hole will allow tapped metal fragments to escape. You’ll end up tapping a blind hole without this cross

hole: be extremely careful if tapping a blind hole; small #2 taps are likely to break if forced into a blind hole containing metal fragments. This picture shows the center drilled and cross drilled shaft.
